EXPERIMENTAL PROGRAM FOR THE DEVELOP-MENT OF IMPROVED HELICOPTER STRUCTURAL CRASHWORTHINESS ANALYTICAL AND DESIGN TECHNIQUES. VOLUME I. COMPUTERIZED UNSYMMETRICAL MATHEMATICAL SIMULATION AND EXPERIMENTAL VERIFICATION FOR HELI-COPTER CRASHWORTHINESS IN WHICH MULTI-DIRECTIONAL IMPACT FORCES ARE PRESENT

## USAAMRDL TECHNICAL REPORT 72-72A EXPERIMENTAL PROGRAM FOR THE DEVELOPMENT OF IMPROVED HELICOPTER STRUCTURAL CRASHWORTHINESS **ANALYTICAL AND DESIGN TECHNIQUES**

**VOLUME I**

CONTRACT DAAJ02-71-C-0066 LOCKHEED-CALIFORNIA COMPANY **BURBANK, CALIFORNIA**

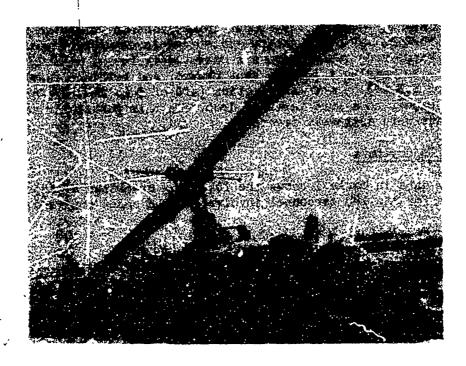
Figure 13. Side View, High Vertical Rate of Descent (Accident Case 30).

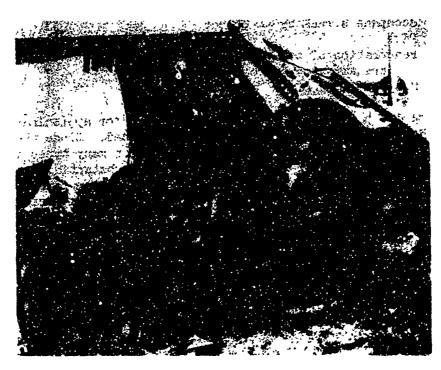
Figure 14. Close-Up View, High Vertical Rate of Descent (Accident Case 30).

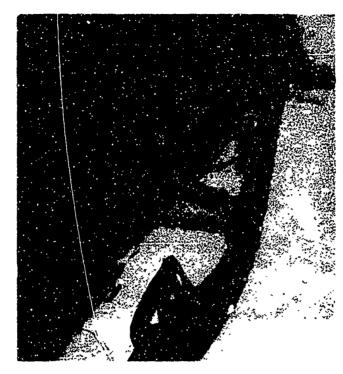
Figure 68. Posttest Damage, Left Landing Skid.

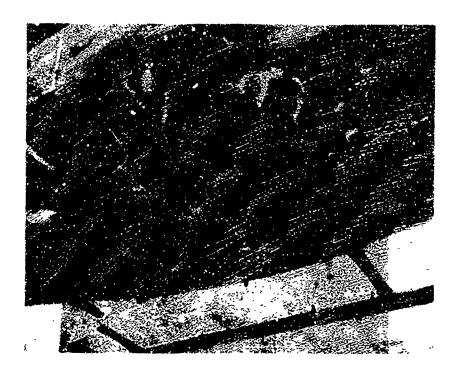
Figure 70. Posttest Damage, Fuselage Underside.

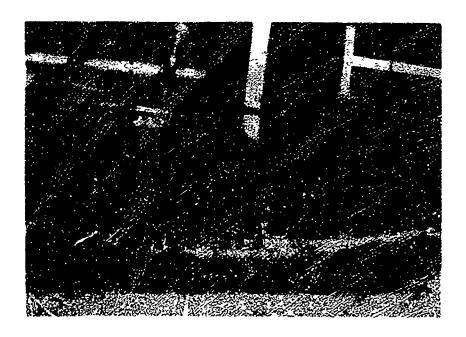
Figure 71. Posttest Damage, Fuselage Side.

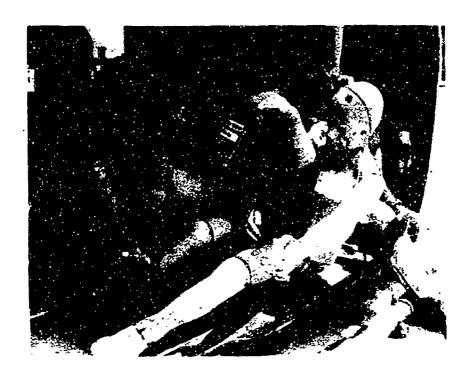
Figure 76. Posttest Damage, Passenger Second Row, Center, and Left Center.
